MILL POND DAM

NH 00387

PRELIMINARY INSPECTION REPORT
NATIONAL DAM INSPECTION PROGRAM

DECEMBER 1980

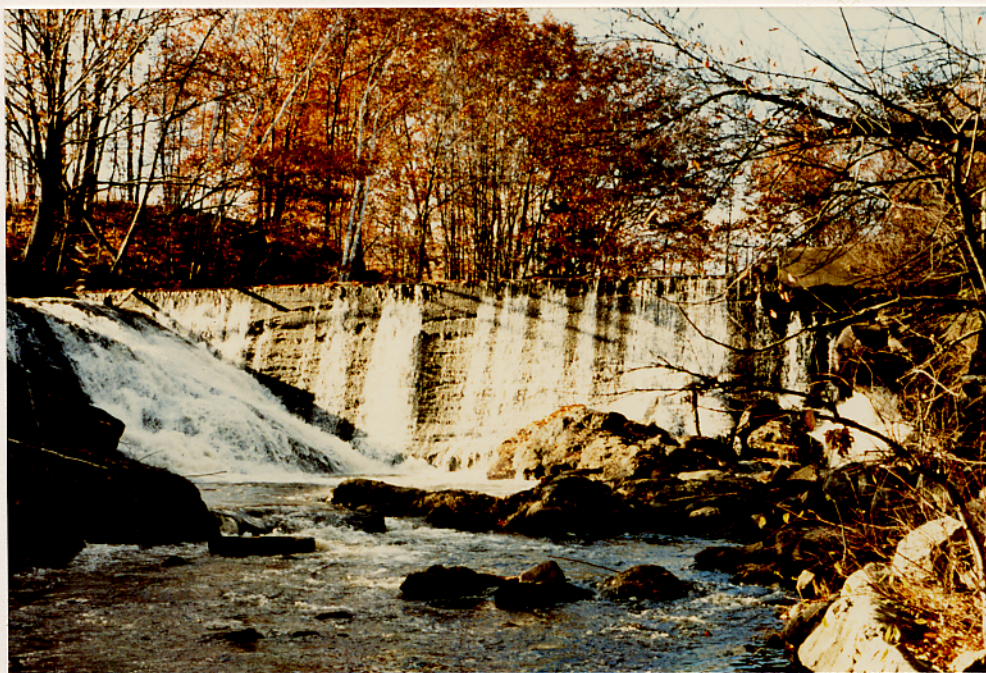
The dam consists of a gravity, overflow type spillway constructed of concrete and founded on bedrock. The spillway is generally in fair condition except for a 6 foot section of the right side that has deteriorated and accumulated low flow debris. There is an abandoned penstock at the left abutment which has been plugged but is leaking at the present time. The dam is approximately 80 feet long and 24.1 feet high with a spillway crest length of approximately 60 feet. The spillway crest elevation is approximately 160 feet (NGVD) with approximately 2.1 feet of freeboard. The right abutment is bedrock and serves as a training wall downstream. The remains of a burned sawmill structure are located at the left abutment. There are no operable outlets at this dam and no means of lowering the reservoir in an emergency. A detailed inspection was not made.

1. Spillway From Downstream - Note: Flow Over Bedrock at Right Abutment

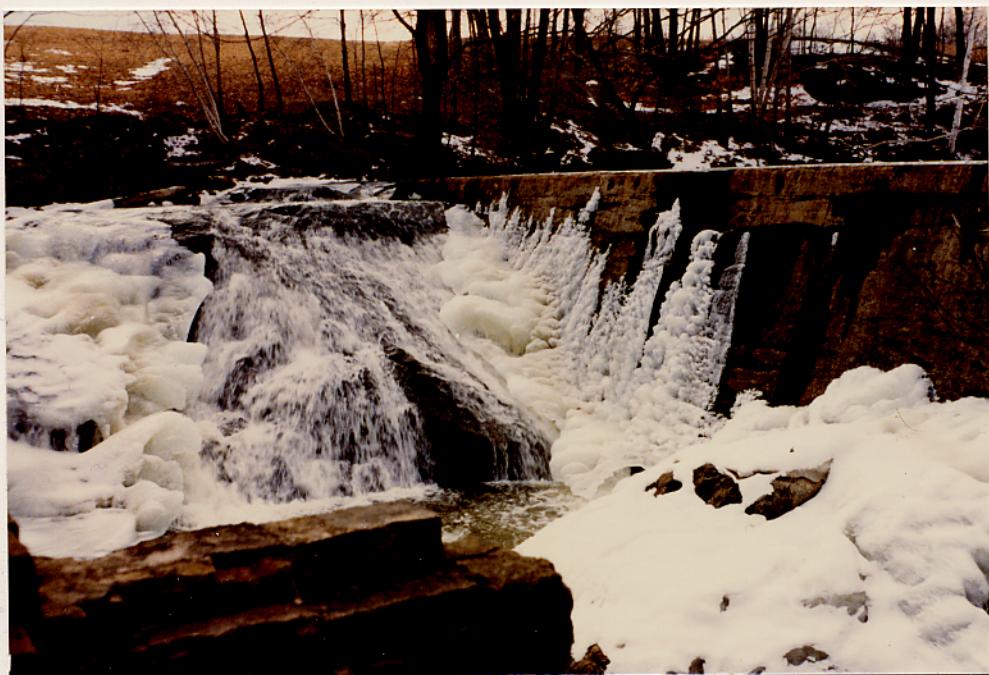
2. Spillway During Winter - Note: Exposed Face

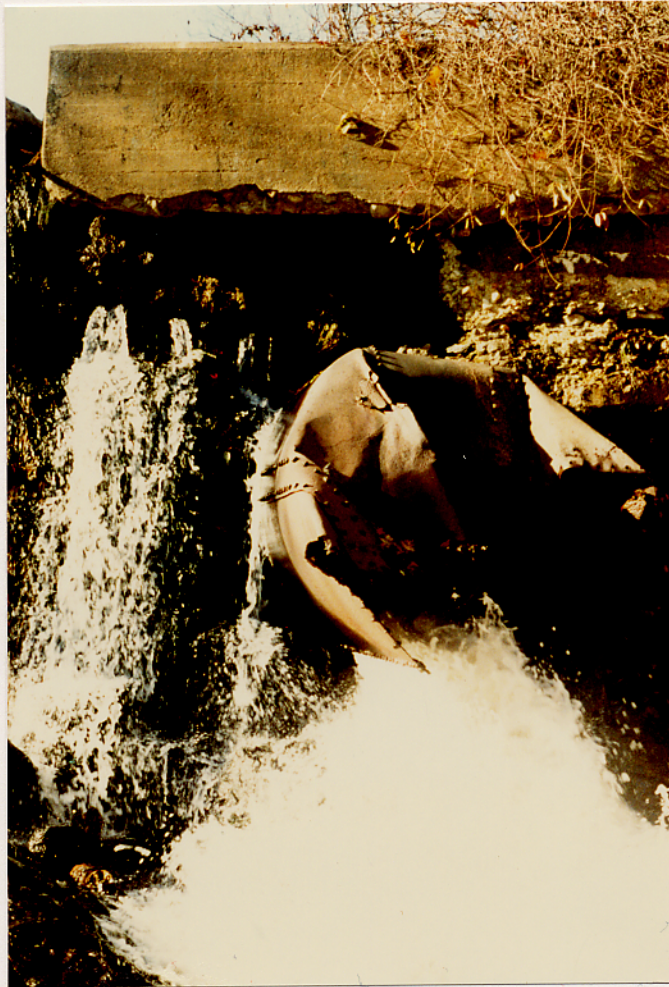
3. Downstream End of Abandoned Penstock - Note: Seepage Through Wall

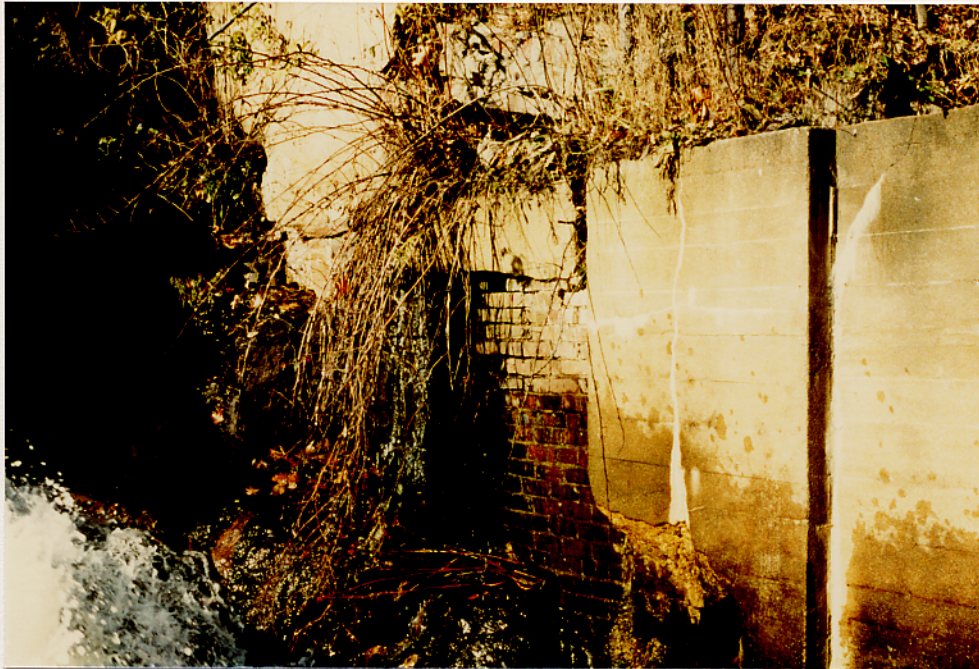
4. Walls of Abandoned Mill at Left Abutment

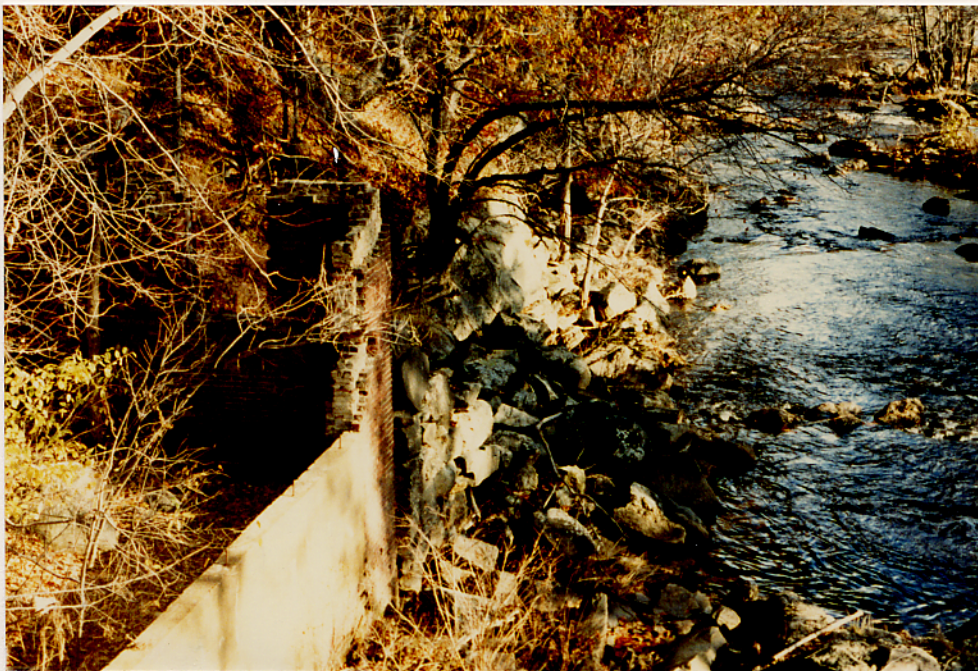
5. Downstream Channel and Remains of Mill Building
